Thatching in the Outer Hebrides

Alan W. Scott

Purpose – The purpose of this research is to report on the surveying of three vernacular thatched properties in the Outer Hebrides, Scotland, all run as Youth Hostels.

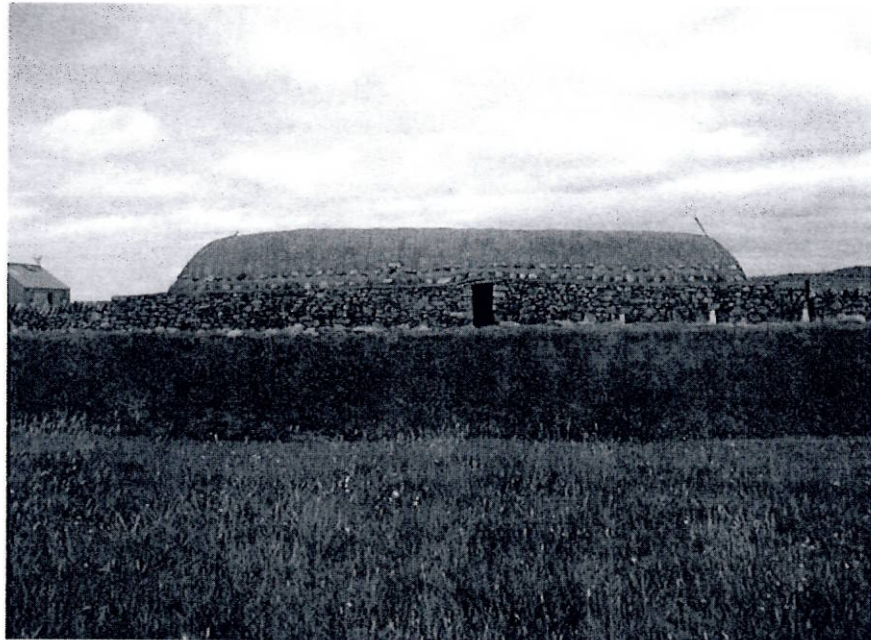
Plate 1.
42 Arnol

42 Arnol on the Isle of Lewis in the Western Isles is owned by Historic Scotland and is acknowledged as the traditional and most authentic thatched “blackhouse”. The property represents the “final stages in the development of an ancient building type built to entirely different principles to those in general use today” (Walker and McGregor, 1996) (see Plate 1).

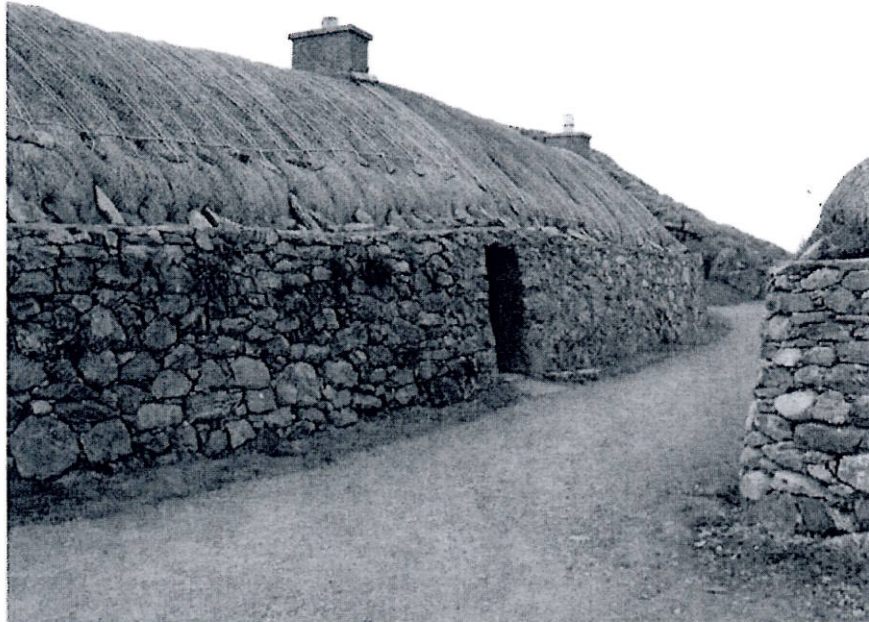
Plate 2.
Garenin hostel

Garenin (Grid Ref. NB 195 443) on the Isle of Lewis consists of a single hostel, but is within a small community of similarly thatched properties, forming part of the Garenin Historic Village. This incorporates hostel, holiday cottages and museum properties (see Plate 2).

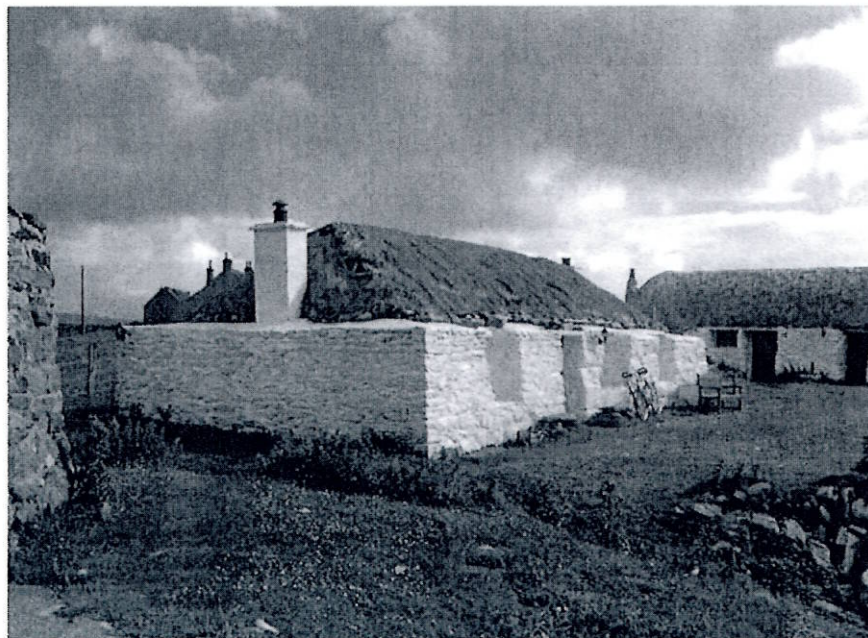
Plate 3.
Berneray, main building

Berneray (Grid Ref. NF 931 814) on the Isle of Berneray, North Uist was opened as a hostel on 16 April 1997 and consists of two buildings used as a living/kitchen and dormitory accommodation. Both buildings are thatched and were consequently surveyed (see Plate 3).

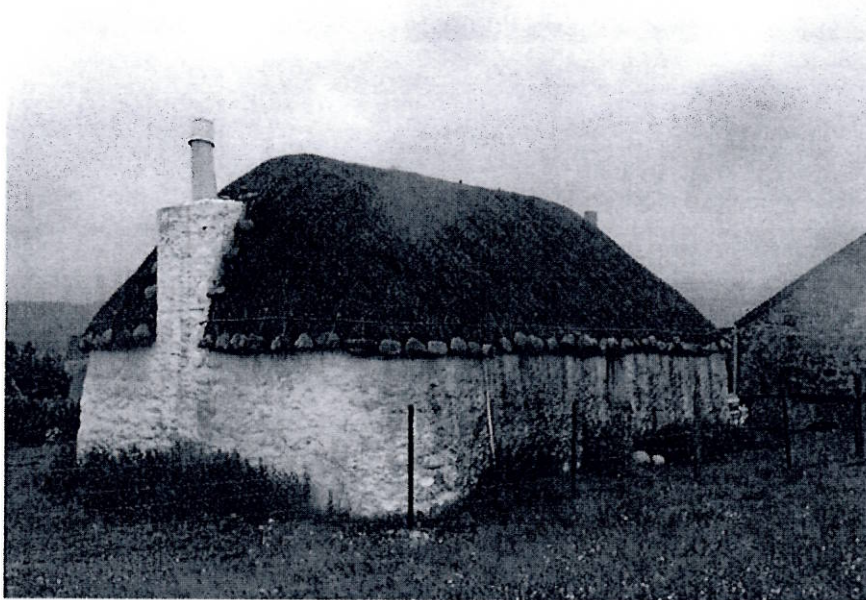
Plate 4.
Howmore hostel

Finally Howmore (Grid Ref. NF 757 364) on the island of South Uist was bought by the Trust in 1966 and consists of two buildings, a living/kitchen unit and a dormitory unit. Only the dormitory unit is thatched and consequently was surveyed (see Plate 4).

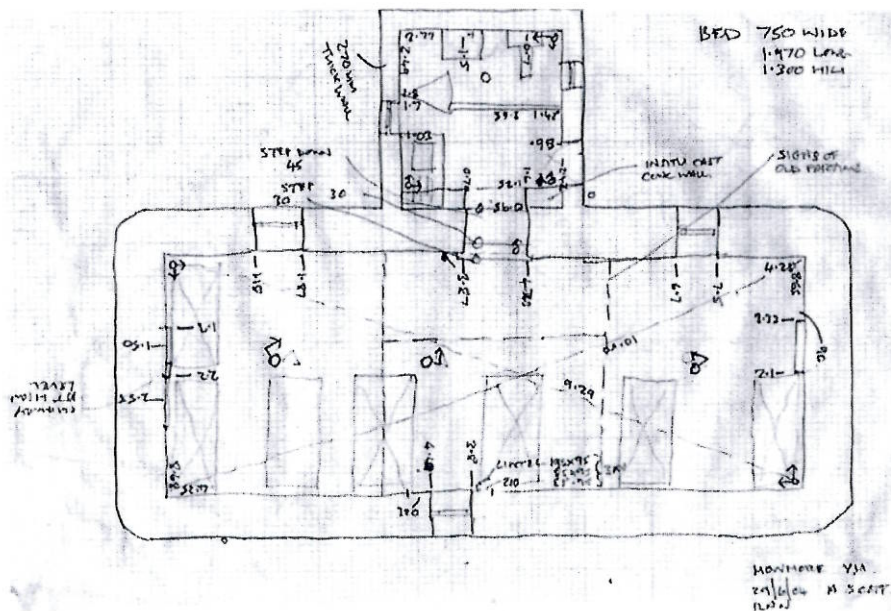
Figure 2.
Howmore site sketch

The author surveyed the properties in 2004, with assistance from Lynne Scott and Neil Wise. The survey work took the format of a measured survey recording plan form, roof structure and covering method. This produced floor and roof plans, elevations and cross-sections, along with identifying construction details (see Figure 2).

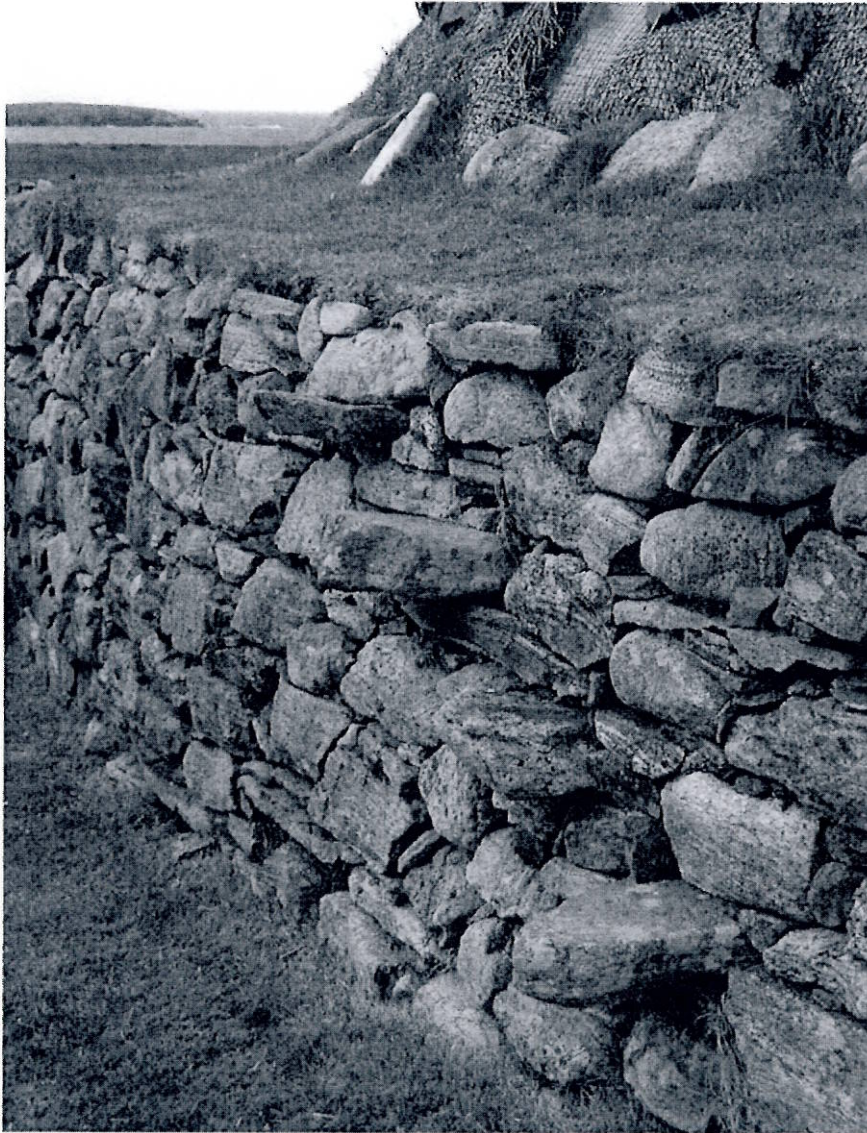
Plate 5.
42 Arnol, access steps

To the top of the wall a platform (*tobta*) is formed which serves two functions. Firstly it deflects wind away from the base of the thatched roofing so protecting the thatch, and secondly to form a platform giving access to the roof for annual maintenance of the thatch. At 42 Arnol protruding stepping-stones to the external face provide easy access to this platform. The top core of the wall is protected at 42 Arnol by blue clay, excavated from the base of peat cutting and then overlaid by turf, cut and maintained by Historic Scotland (see Plate 5).

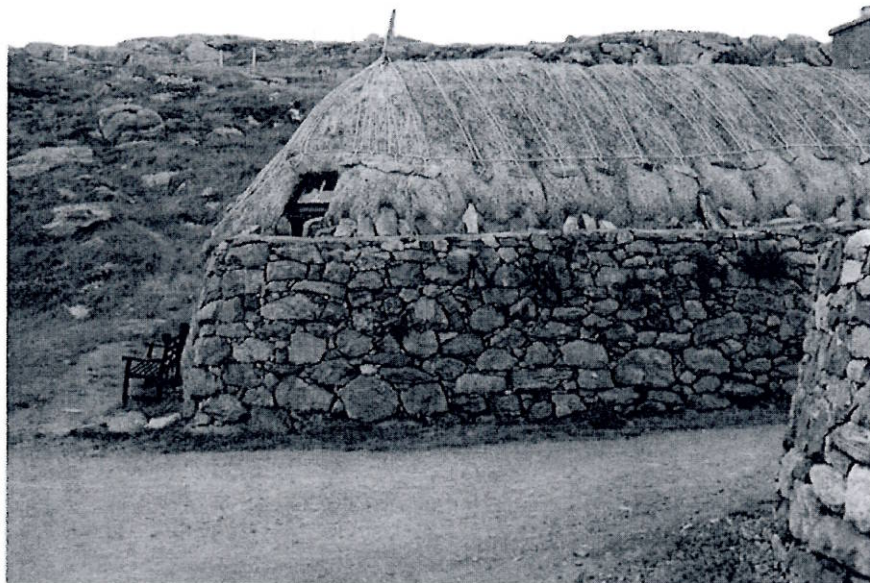
Plate 6.
Garenin hostel, stonework
to bell end

The walls of the main building vary in height from 1.85 to 2.3 m to the frontage, although this is reduced to the rear due to rising ground levels. The whole site however, slopes down to the northwest and the bay of Geodha Ruadh and the general siting of the black houses at Gearrannan is such that the byre is lower than the living quarters within the dwelling. This is typical of blackhouse construction and was designed to allow smoke from the peat fires to rise to the living quarters and not affect cattle within the byre (see Plate 6).

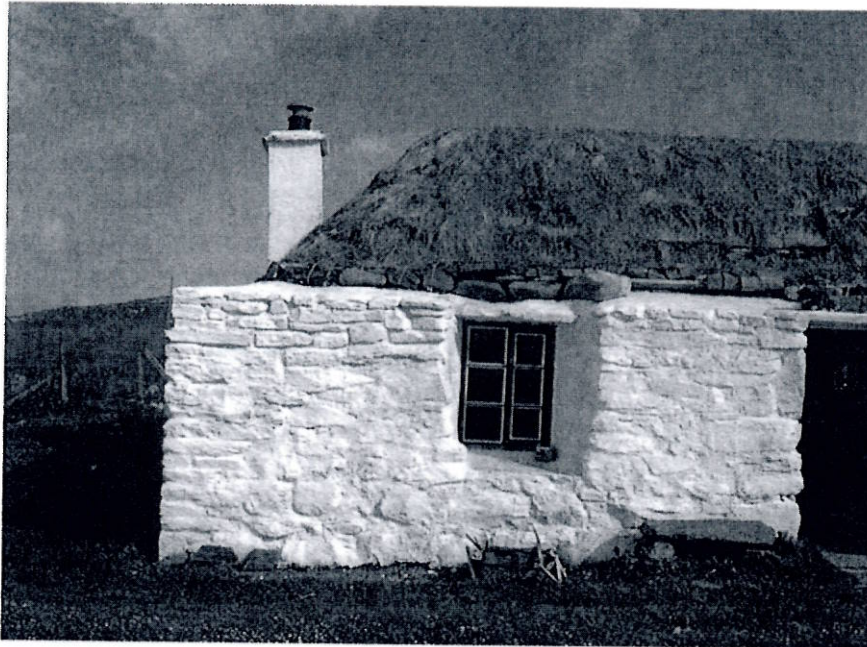
Plate 7.
Berneray, main building
showing eaves platform

A platform is formed at eaves level for thatch access as at Garenin, but no access steps are formed as at Arnol. The top of the wall appears to have been rendered, although no exploratory destructive testing was undertaken. External walls have window openings approximately 1 metre by 1 metre, giving good light levels internally with windows having stone and concrete lintels. Again this is not typical of 42 Arnol, which does not have windows, or Garenin having a window incorporated as a later alteration (see Plate 7).

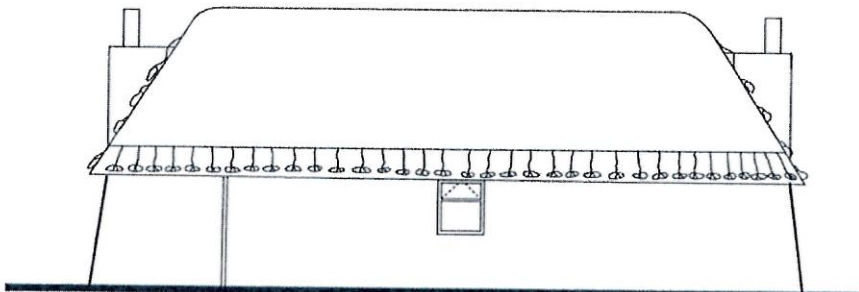
Figure 3.
Howmore rear elevation
sketch

Howmore on the island of South Uist measures internally 8.65 m by 4.25 m and is consequently less like Arnol than the other buildings. The walls are 900 mm thick with an external batter of approximately 200 mm. Internally the walls are generally around 2 m high. No platform is formed at eaves level as the thatch overhangs the eaves by approximately 200 mm. Windows are formed to either side of the front porch giving a symmetrical appearance. Another window is incorporated to the rear. Generally lintels are of timber and externally stonework has been pointed and then limewashed. Internally the building is a single unit with no partitions to the main area. Fireplaces are sited to the gable walls, externally culminating in stone chimney stacks with concrete copings (see Figure 3).

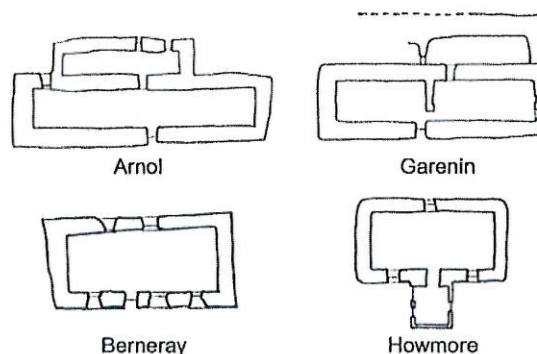
Figure 4.
Plan form sketch

and include a retaining wall built against the original structure. This later extension is covered with corrugated iron sheeting and presents detailing problems at the junction of the thatch roofing (see Figure 4).

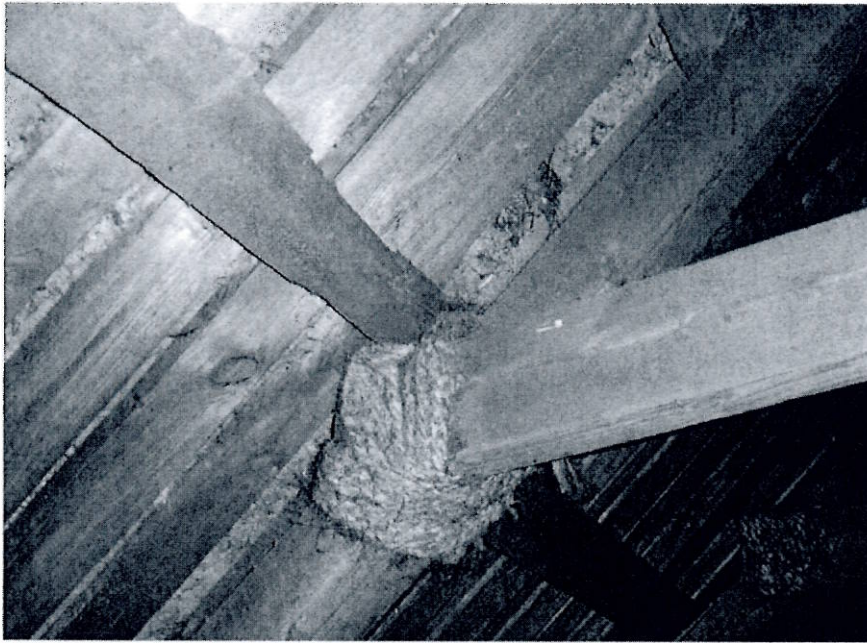
Plate 8.
42 Arnol, binding of roof
truss members

All of the three properties have new roof structures, but even 42 Arnol has been restored. The Arnol roof consists of "a series of A-frame trusses rising from the inner skins of the wall" (Walker and McGregor, 1996). The trusses support purlins located below and above the tie. The tie to the truss is bolted and then purlins and ridgepoles are lashed together with coir yarn (see Plate 8).

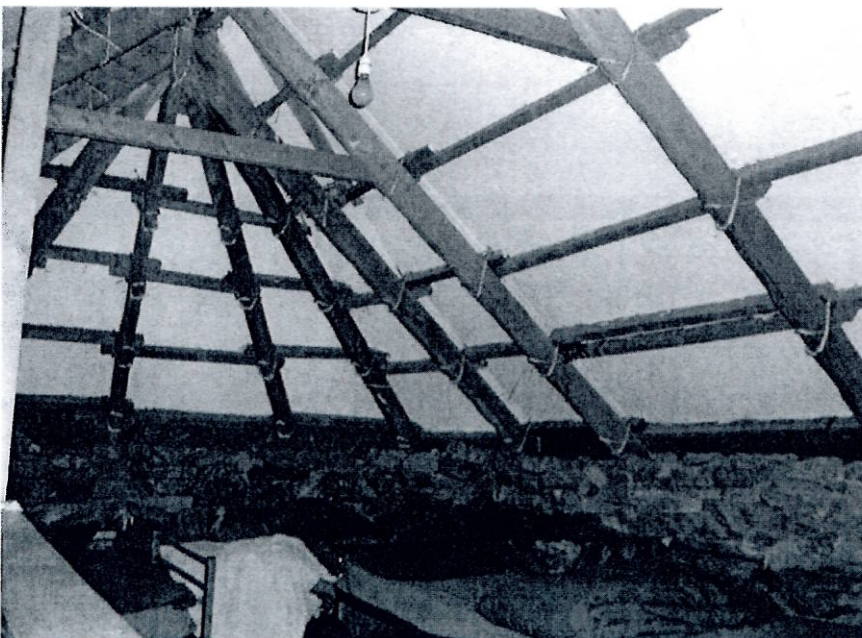
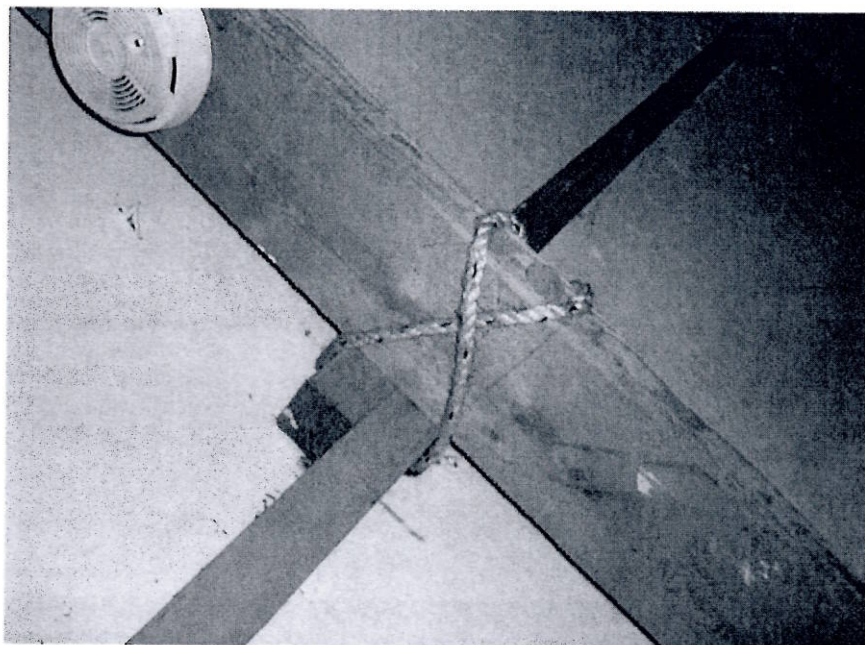
To the north-west bedroom area, three pairs of A-frame trusses of 150 mm by 47 mm timbers carry five purlins per elevation. The chord to the A-frame truss measures 100 by 50 mm and is bolted to the principal rafter section. Purlins measuring 75 mm by 47 mm are lashed to the principal rafter, but unlike Arnol the roping is 12 mm diameter plastic rope, not coir yarn. To the bell hipped gable seven principal rafters span from ridge level to rest on the internal wall structure. All of this part of the roof is overlaid with 19 mm chipwood painted white (see Plates 9 and 10).

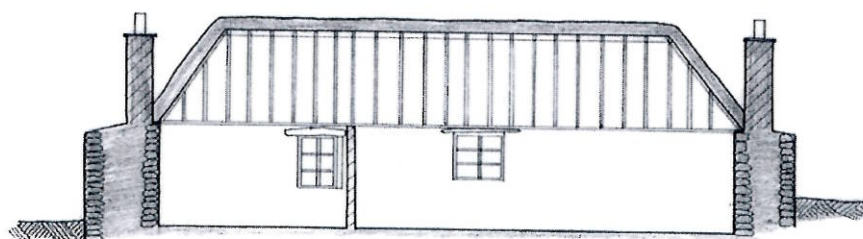
Figure 5.
Berneray cross section
plan

To Berneray hostel the main building consists of 100 mm by 50 mm rafters at 400 mm centres with a high-level tie and 150 mm by 25 mm ridge board. At gable ends the roof structure is formed to a hip including jack rafter details. Rafters are overlaid with plywood sheeting all with a stained decorative finish. Externally to the south-west corner thatching in missing and here a section of sarking felt and timber boarding is visible over the plywood sheeting (see Figure 5).

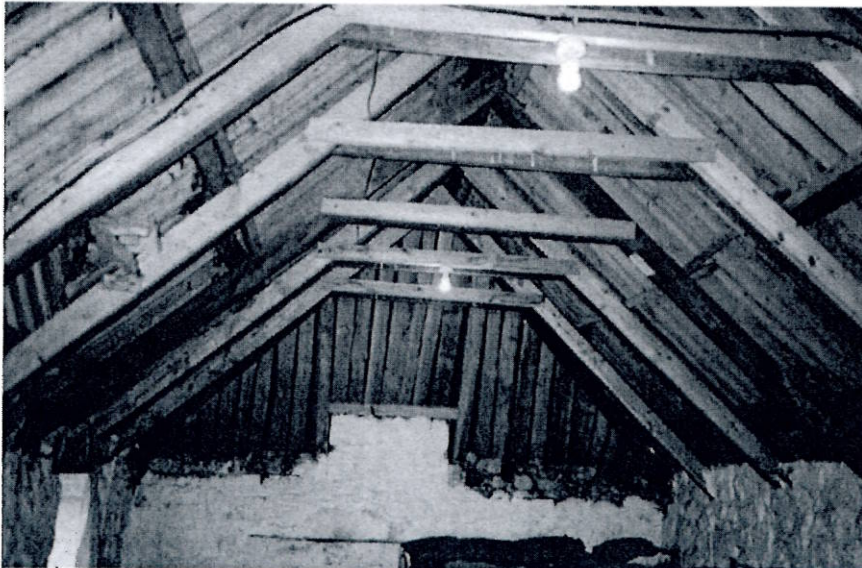
Plate 11.
Howmore, roof structure

Howmore on South Uist again uses sawn timbers indicating an imported roof structure. The roof consists of eight A-framed trusses consisting of 125 mm by 50 mm timber, which to six of the eight trusses have been doubled up with two rafter sections. Hip rafters are formed to the gables, and around the raised chimney section rafter and trimmer timbers are constructed. Three purlins per elevation are installed ranging in size from 75 mm by 50 mm to 125 mm by 50 mm (see Plate 11).

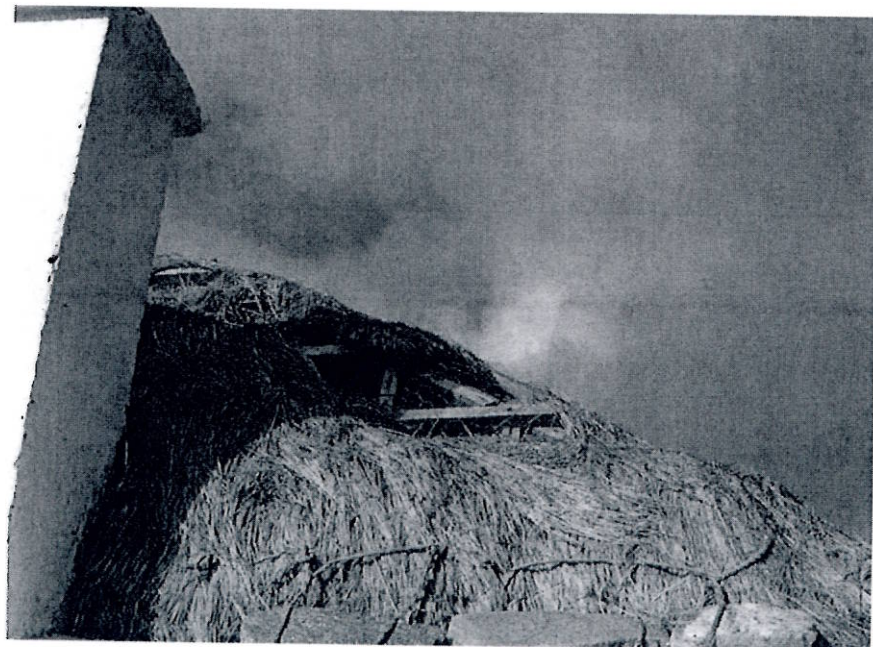
Plate 12.
Berneray hostel, missing
thatch to hip

At Berneray the sub-base is visible to the south-east corner where the thatch is missing to reveal a sarking felt and 50 mm by 50 mm battens formed to a framework. The marram grass thatch is covered with wire netting and at eaves level the wall head is exposed and decorated. The thatch is of variable thickness and shows areas of compression with the outline of timber battens visible (see Plate 12).

To Berneray in 2004 areas of thatch were missing, especially to the front hip detail with the timber framework exposed, and the water tightness of the roof relies on the under felting. Especially to the annexe roof, bricks are used to hold down the securing netting and in future these should be retained "all replacements should be in character with the rest of the roof no matter how bizarre" (Walker *et al.*, 1996). Berneray was last re-thatched in 2000 with the Macair (local sand dunes) providing the marram grass.

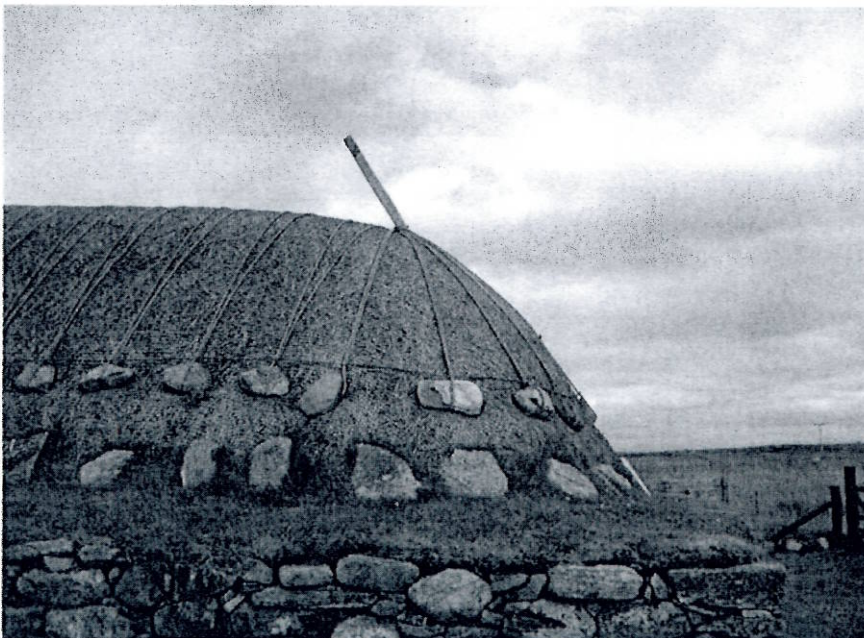
Plate 13.
Arnol bell end showing
stone and rope securings

"At the apex of each hip a protruding "Raven Stick" or "*Maide Feannaig*" serves as an anchor for the ropes that hold the thatch on the hip (Fenton, 1995) (see Plate 13).

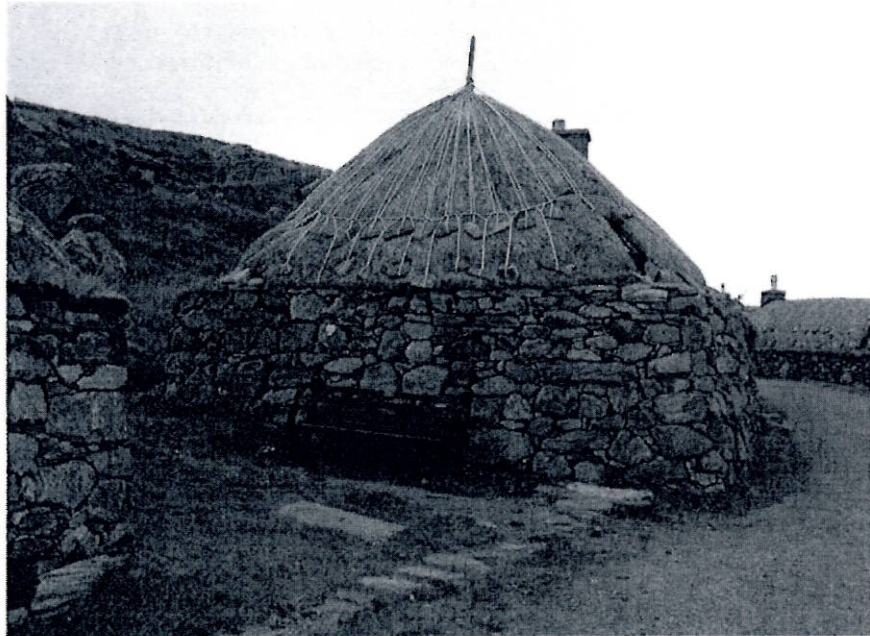
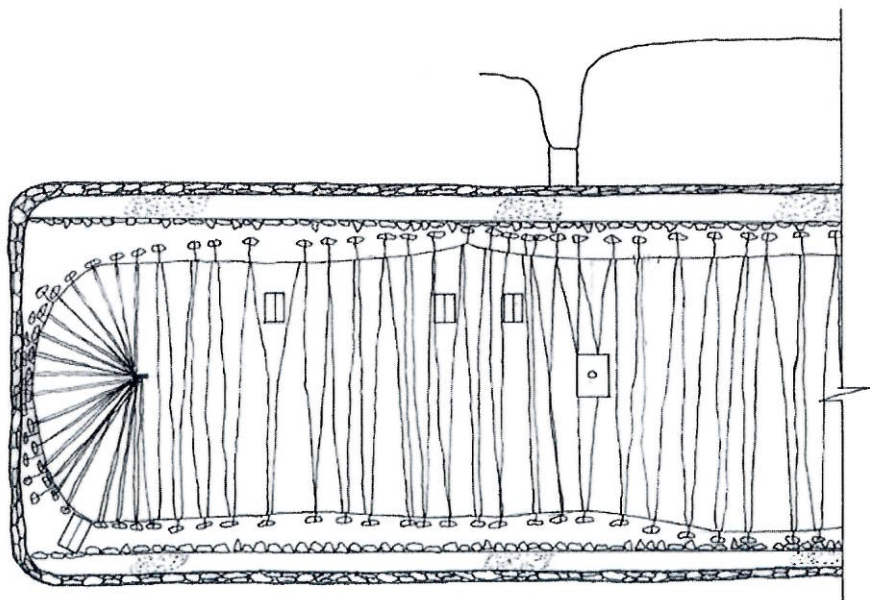
At Garenin, the property closest to Arnol, both physically and in construction terms, stones are placed at the junction of the thatch and wall head, measuring 450 mm by 250 mm. Suspended stones approximately 300 mm by 200 mm are secured by 15 mm diameter rope, twisted to the stone to prevent loss. To the previously rebuilt southeast gable the roping is taken over the verge in a laced pattern and secured to 25 mm square timber pegs (six per elevation) fixed into the masonry and protruding about 160 mm (see Plate 14) and Figure 6).

The roping to the roof is laced vertically over the ridge and to the hipped end is twisted around the "Raven Stick" in the manner of Arnol. Above the suspended stones a horizontal rope is run around the roof to secure the position of the stones.

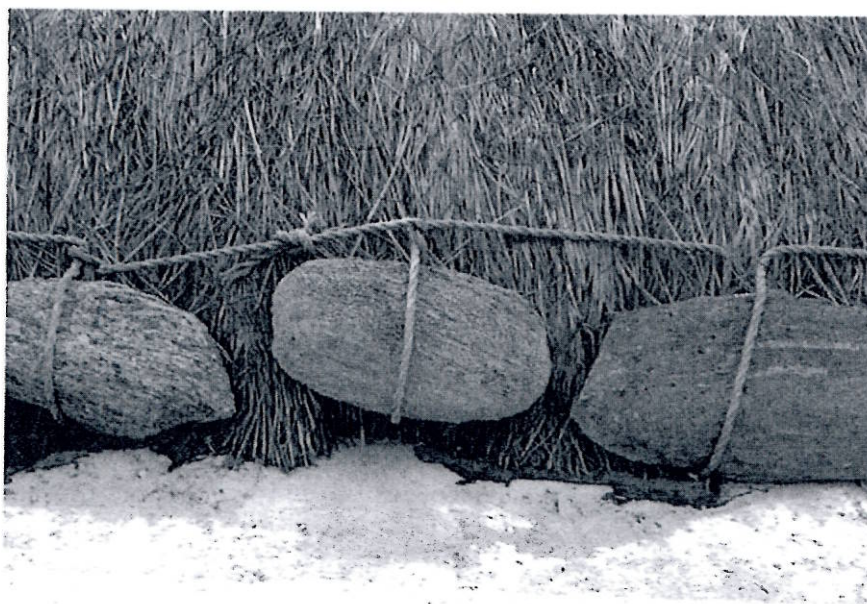
Plate 15.
Berneray, securing stones
to eaves level

At Berneray no vertical ropes are incorporated and hanging stones are secured by 12 mm diameter blue plastic rope passing around the perimeter of the roof and securing the stones approximate size 300 mm by 200 mm. Timber driftwood also assists in the securing of stones, particularly over door openings. Bizarrely old bricks are partly used in lieu of stones (see Plate 15).

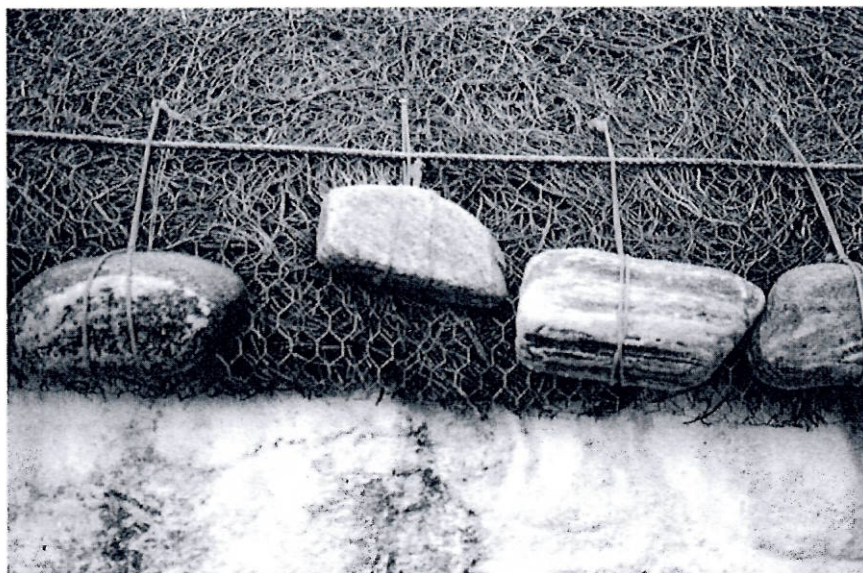
Plate 16.
Howmore, stone securing

At Howmore the thatch overhangs the wall head as previously discussed and the roping consists of 12 mm diameter roping run around the perimeter of the roof and fixed adjacent to chimney stacks with 25 mm diameter silver birch pegs. A total of 85 stones are suspended to the perimeter of the roof with additional stones suspended to the chimney stacks and valley areas. The stones, measuring approximately 250 mm by 170 mm, are fixed to the perimeter of the roof with 5 mm diameter green plastic rope (see Plate 16).
